Hebron, NH

# Town Common Analysis

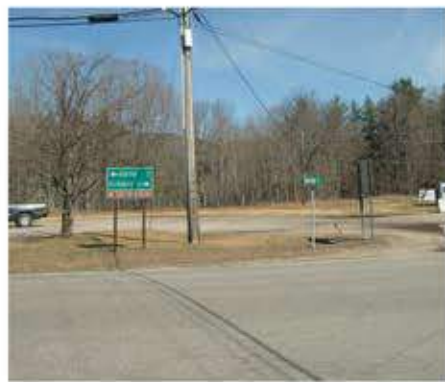
Throughout the common there are a variety of signs. Some signs are standard signs that meet NH street sign standards, others are locally developed signs. At the east end of the common there is a collection of signs that are traffic control signs and informational signs. (pictured to the right, first picture)

When entering the town, with the exception of the “No Outlet” sign (pictured to the right) the rest of the signage cannot be seen and is insignificant to drivers. They are placed back beyond the large pine tree and the lettering on the sign is too small. These signs should be reprinted and slightly enlarged for easy viewing. Consideration should be made to bring all the signs in one location and define the space with a welcoming

appearance ie. a low landscape space, that is low maintenance, but still appeals to the historic nature of the town.

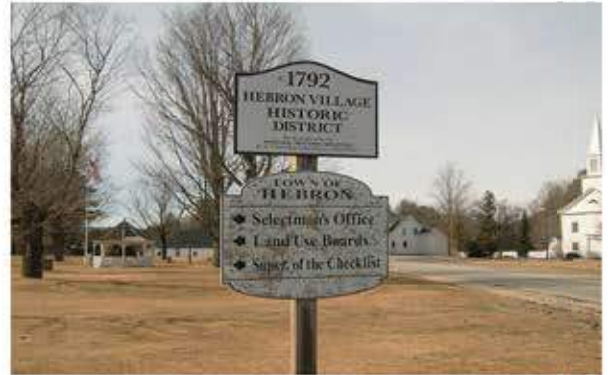
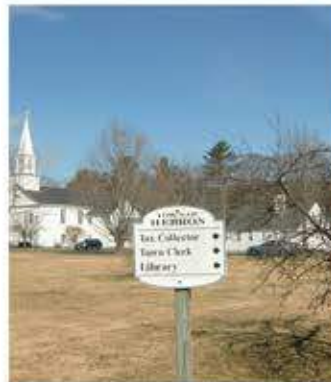
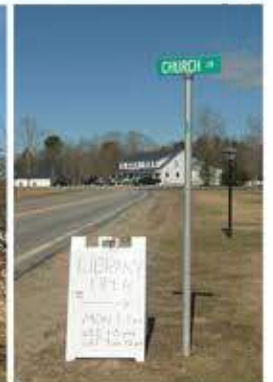
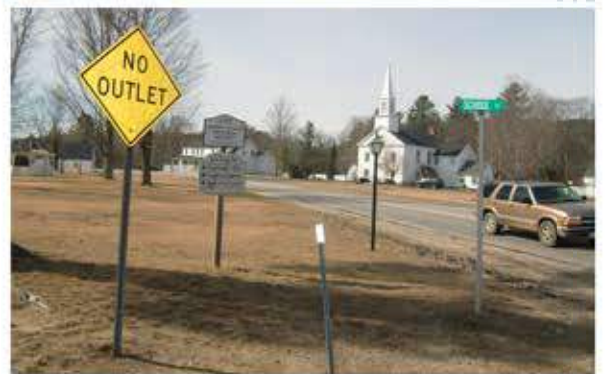
Across the street from the previous signs is located a sandwich board sign (pictured to the right, third picture down) which is displayed on Mondays, Wednesdays and Fridays. The sandwich board sign

announces library days and hours. The sign is almost non-readable to a moving vehicle. There is also the Church St. sign located in this area.

Near the old fire station there are State of New Hampshire directional signs and the Governor Nathaniel Berry historic site sign (bottom picture on the left). The historic sign is significant to the historic character of the town and should have some way of visually getting attention rather than just another historic sign located on the side of the road. Signs that are near the common ie. store signs, the bicycle route signs and the church sign should be considered to be coordinated when standardizing the signage in and around the common area.

As with the sign area located at the point of the common, these signs should be slightly enlarged to be read by the motoring public and placed so that they are in a “sign” landscape space, including the street sign. The library sign can be made into a more permanent sign with the option of being able to change the hours or announcing library events. This could also be a location for the church sign and allow announcements ie. “Saturday night super”. The church occasionally places a sandwich board at the opposite side of the common announcing their events.

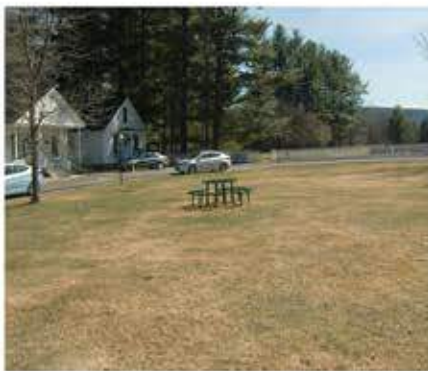
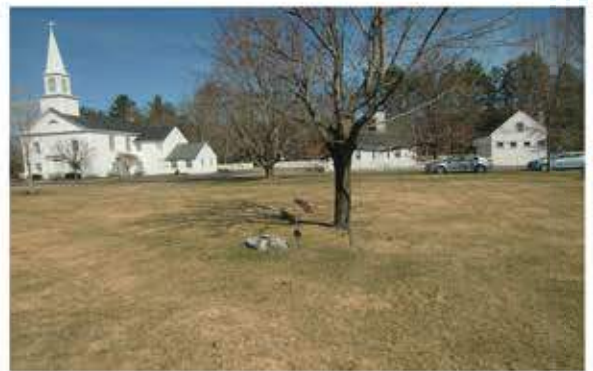
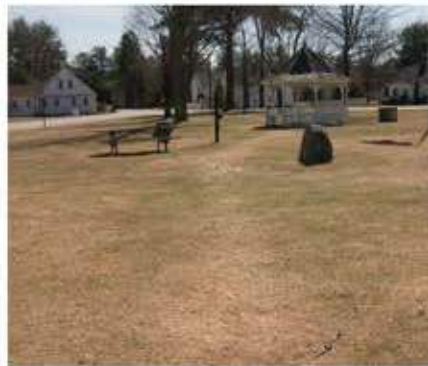
**Monuments and Markers** (pictured to the right, middle 3 pictures): There are several markers and monuments that have been placed throughout the common area. There is no apparent reason for their locations except for the fact that someone liked a particular spot. Consideration should be made to place all the markers or stone monuments in one location so they can be viewed at one time.

The location near the existing rhododendrons might be a fitting location. It can be created into a special memorial. If the monument plaza idea is accepted the flag pole next to the gazebo should be part of that area.

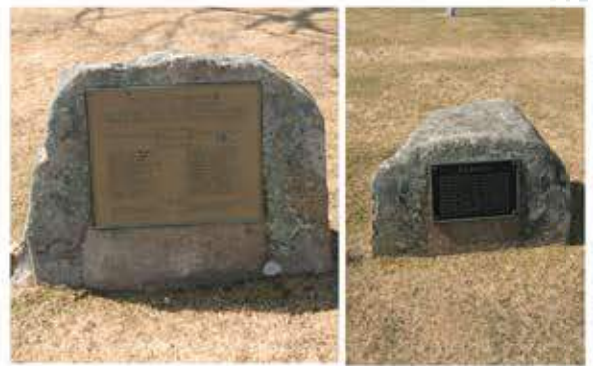
**Gazebo** (last picture on the right) : The gazebo appears to be in sound condition and in a good location the only issue is

that the access to the gazebo should be more west than it is now located. This is an easy fix and a good carpenter can move the existing rail and banisters to the existing opening.

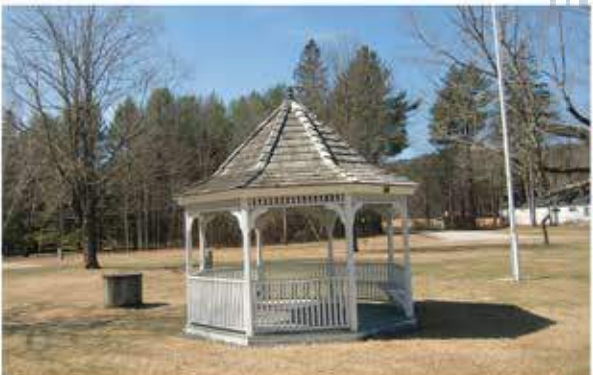
**Picnic Tables** (pictured within the text above): The picnic tables appear to be placed in places that were easy to drop them off. Placing them near some of the trees so they appear to be intentionally placed should be considered. All of the picnic tables should be of one material, not wood in one location and metal in another location.

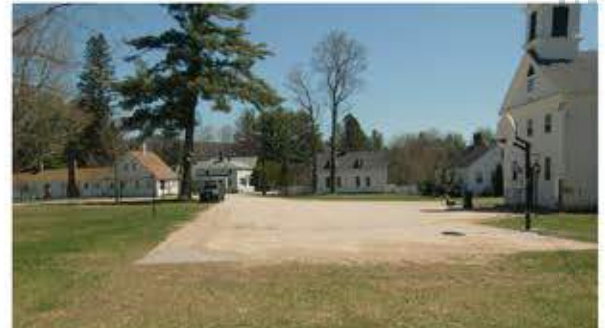
Library and Assesors office parking  
&  
Church Parking

**Parking:** Parking within the “common property” is unstructured. There are paved areas for parking without stripes or other methods of vehicle management. During the time of this review it did not appear to be an issue people seemed to park where they thought it was appropriate. For public and building safety designated parking areas should be created, to provide for orderly parking yet still allow emergency access to any and all the buildings. The area directly in front of the public buildings should be designated as “Fire Zones”. As stated above the basketball area should be separated from the parking area. This area is also a designated bicycle route yet there are no accomindations for bicycle storage in any of the parking areas, town common, town hall, or at the store/post office. **Note: Each parking location should have at least 1 handicap parking spot.**

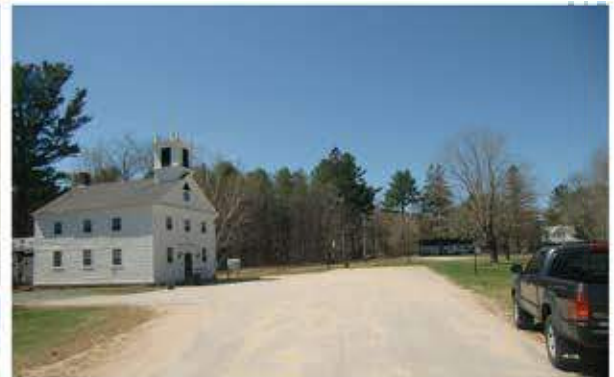
Church parking snow is pushed into the common; snow storage damage

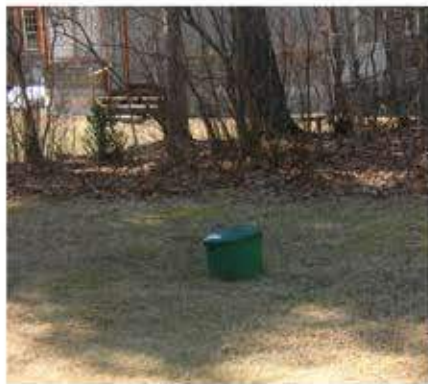
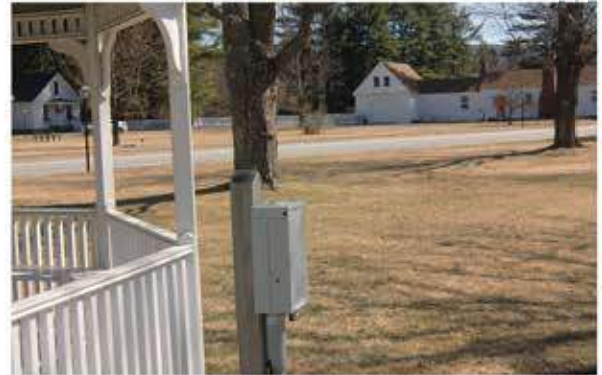
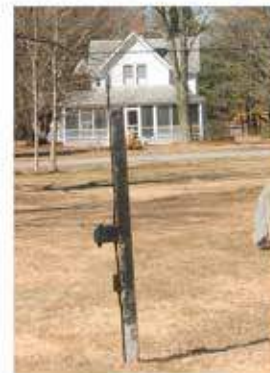
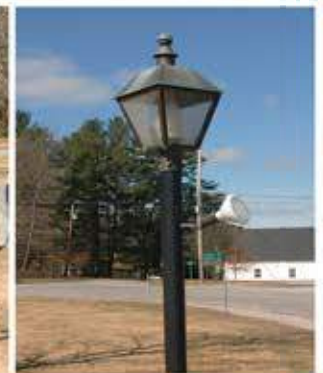
**Electric:** There are no as-built plans showing where any of the electric lines are located on the site. It is not known if the lines are just buried or in conduit. For the purpose of digging or even putting in metal tent stakes this is not a safe situation. There are lights around the common with no pattern of layout. There are posts that have electric outlets on them, one is semi secured. The second one that has the flagpole light on it, the outlet is unsecured. Part of the work on the common should focus on an electrical layout and an as built plan developed so that in the future any repairs or improvements can be made without a lot of exploratory expense. The electrical units should be tied into the gazebo or other structure and not just free standing. The

town has been fortunate not to have vandalism of these units. There are two spot lights, both in reach of the general public, one is on a light post that supposedly lights the steeple of the church (pictured to the right, 3rd picture in the series) the second is located on one of the freestanding electrical posts lighting the flag pole (pictured to the right, second picture in the series).

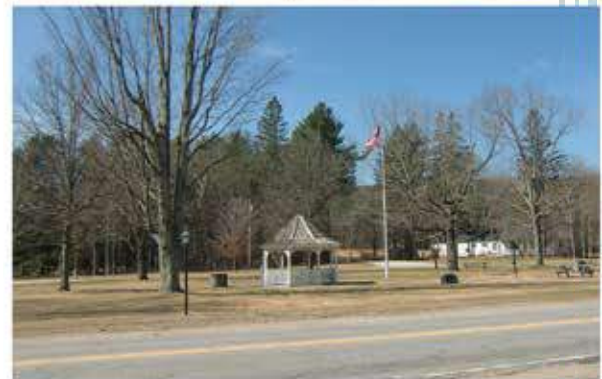
**Well** (pictured directly to the right) : To the south of the gazebo there is what appears to be a well. At this time we know that the well serves the Hebron Academy Building. There is also a cut-off water line from there to the fire station. If it is in need of being replaced or moved then it should be considered to lower the top of the well and moving the Gazebo over the top of the well and install an access cover through the floor of the gazebo.

**Septic system** (pictured directly to the right) : To the right of the "Hebron Academy" Town hall there is a series of sewer manholes, as of this writing there, we are aware that there are two tanks and they pipe to a dry well near West Shore Road. There is no leaching field The septic system will also have to be evaluated and likely be brought up to DES standards. This system will need to be updated or replaced when the building is renovated and expanded.

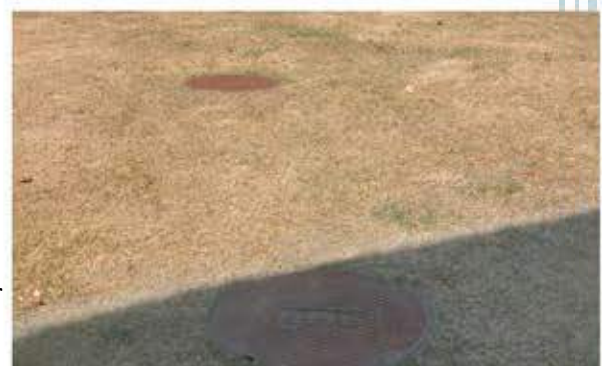
**Buried Propane tank** (pictured within text): Behind the playground and to the right of "Hebron Academy" Town Hall there is a buried propane tank that is unsecured. The propane tank will need to be moved when building is expanded. This should not be near any playground and the cover of the tank should be secured to prevent any possibility of vandalism and for the security of the town office.

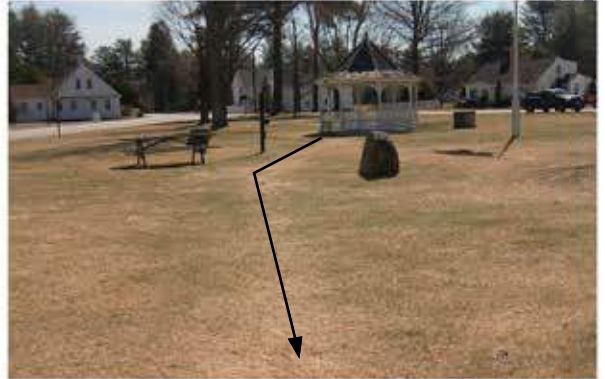
**Swale in the grass** (pictured to the right) : As one walks from the direction of the store to the gazebo there is a curious curvature in the grass. This swale is created by random wires and water lines underneath the grounds of the common. It is in a random location and does not relate to any walking paths or the other elements of the common area. This issue should be addressed.

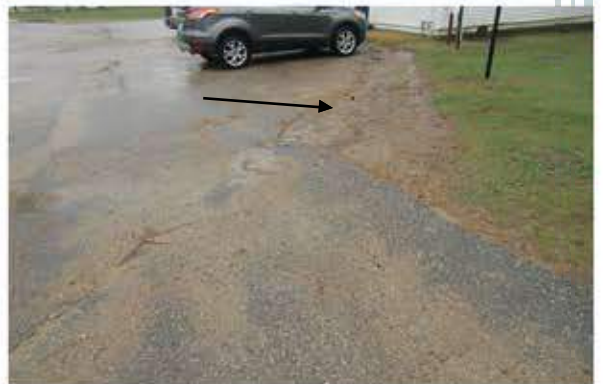
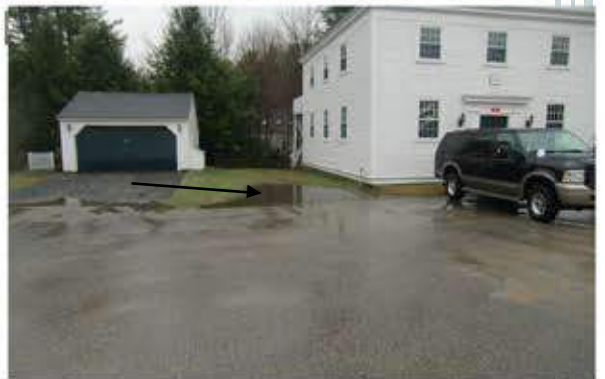
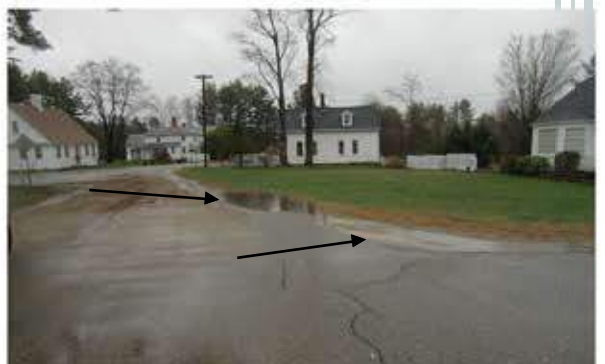
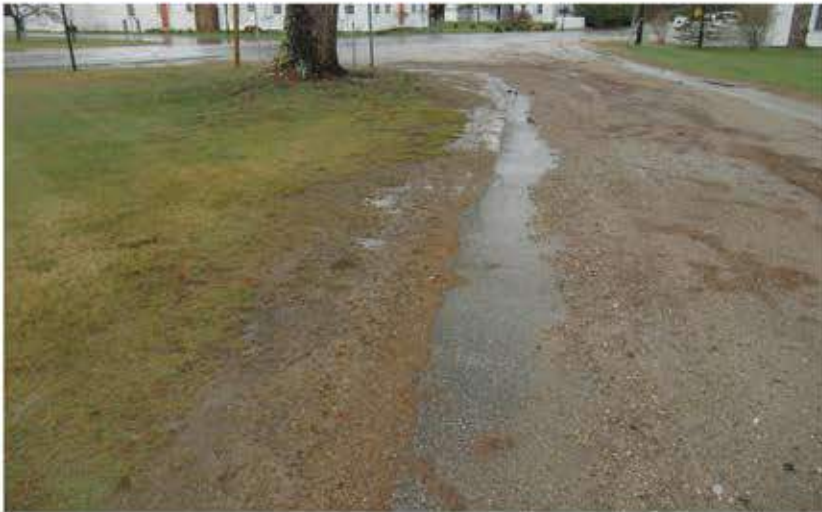
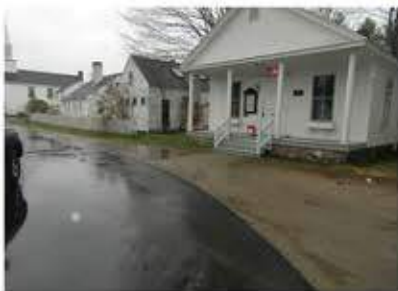
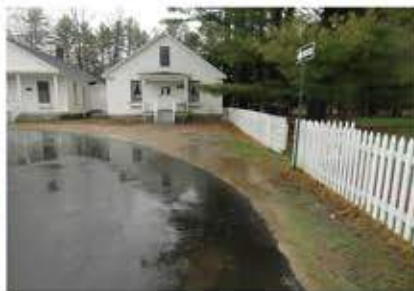
**Storm Water Drainage:** The site was visited on May 2, 2016 after an 18 hour rain event it was found that the parking lot in front of " Hebron Academy" was graded so that the water from a rain event ran towards the building and the playground. There was a significant body of water to the right of the building almost up to the foundation wall. During this observation period there was no buildup of storm water in the playground. It can be assumed that during a downpour period of rain, water does run from the parking lot into the playground. In front of the library and the Town Clerk and Tax Collectors office there were two areas of poor drainage that could be solved with some fill.
